# NATIONAL TRANSPORTATION SAFETY BOARD

## Video Study

### Specialist's Factual Report By Sean Payne

Location: Northlake, Illinois  
Date: April 23, 2020  
Company: Union Pacific  
Train ID: YPR604  
NTSB Number: RRD20LR003  
Summary: Refer to the Accident Summary report, within this docket.

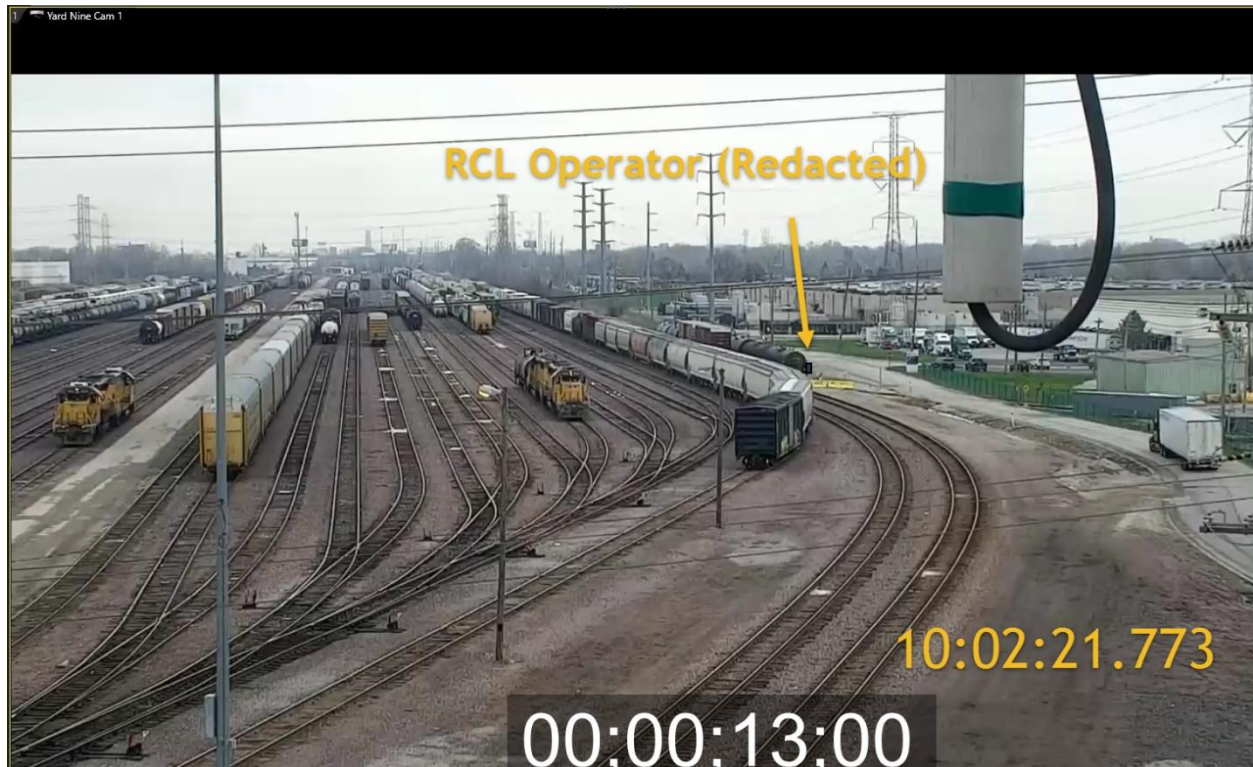
An examination of exported lossless frames showed a change of a group of pixels in the vicinity of the RCL Operator's shoulder at 10:02:21.773, however, at this time the area of the operator's left shoulder was passing in front of an area of varying contrast in the roadbed next to the track. It is possible that the H.264 codec of the video resulted in visual

compression artifacts due to the way the filesystem encodes video. Figure 1 is a redacted screen capture of the frame at 10:02:21.773.

**Figure 1. A redacted security camera frame at 10:02:21.773.**

If the change in pixel density in the vicinity of the RCL Operator's shoulder is assumed to be a hand signal at 10:02:21.773, then the time between the first potential hand signal and impact was 6.93 seconds.

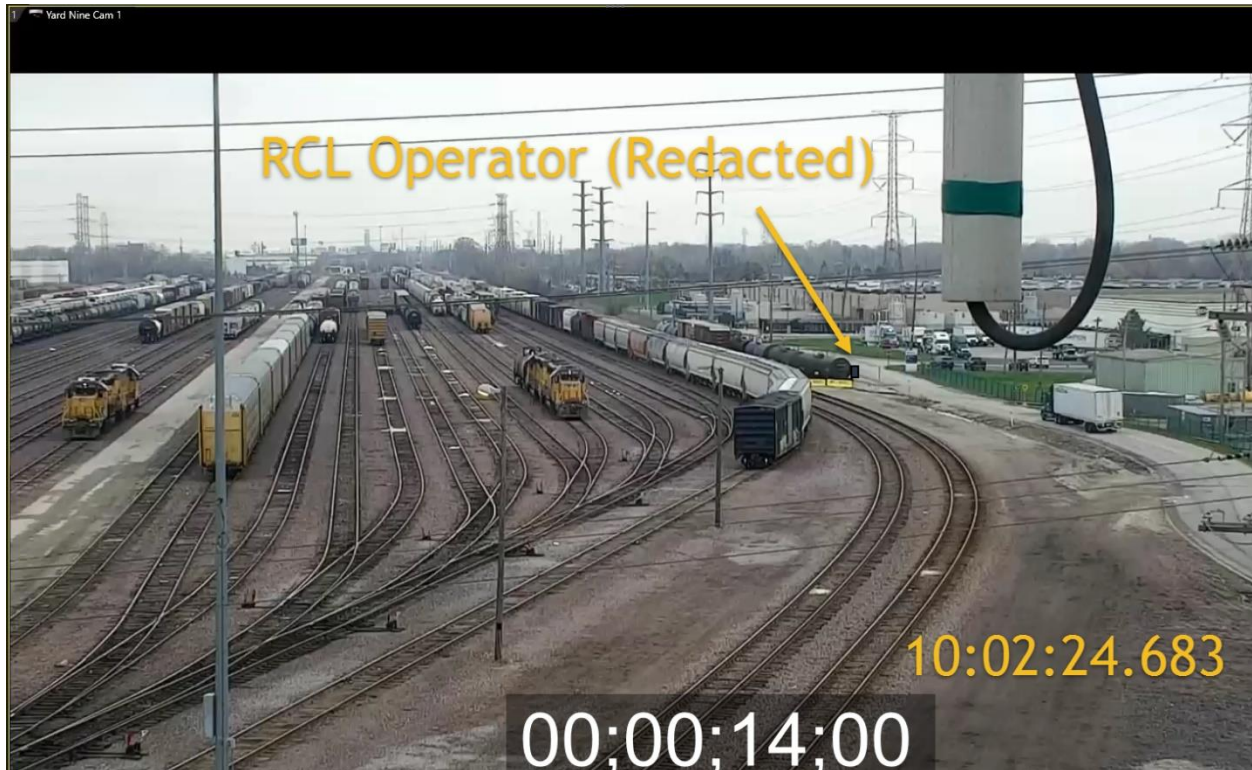
Moving forward in time, at 10:02:24.683, there is a conclusive change in the pixel density in the vicinity of the operator's left shoulder. At this time, there was no change in coloration of the roadbed next to the track (background behind the operator) and it is unlikely that visual compression artifacts were present around the RCL Operator's shoulder. Figure 2 is a redacted screen capture of the frame at this moment at 10:02:24.683.

**Figure 2. A redacted security camera frame at 10:02:24.683.**

The time between the second conclusive hand signal at 10:02:24.683 and impact was 4.02 seconds.

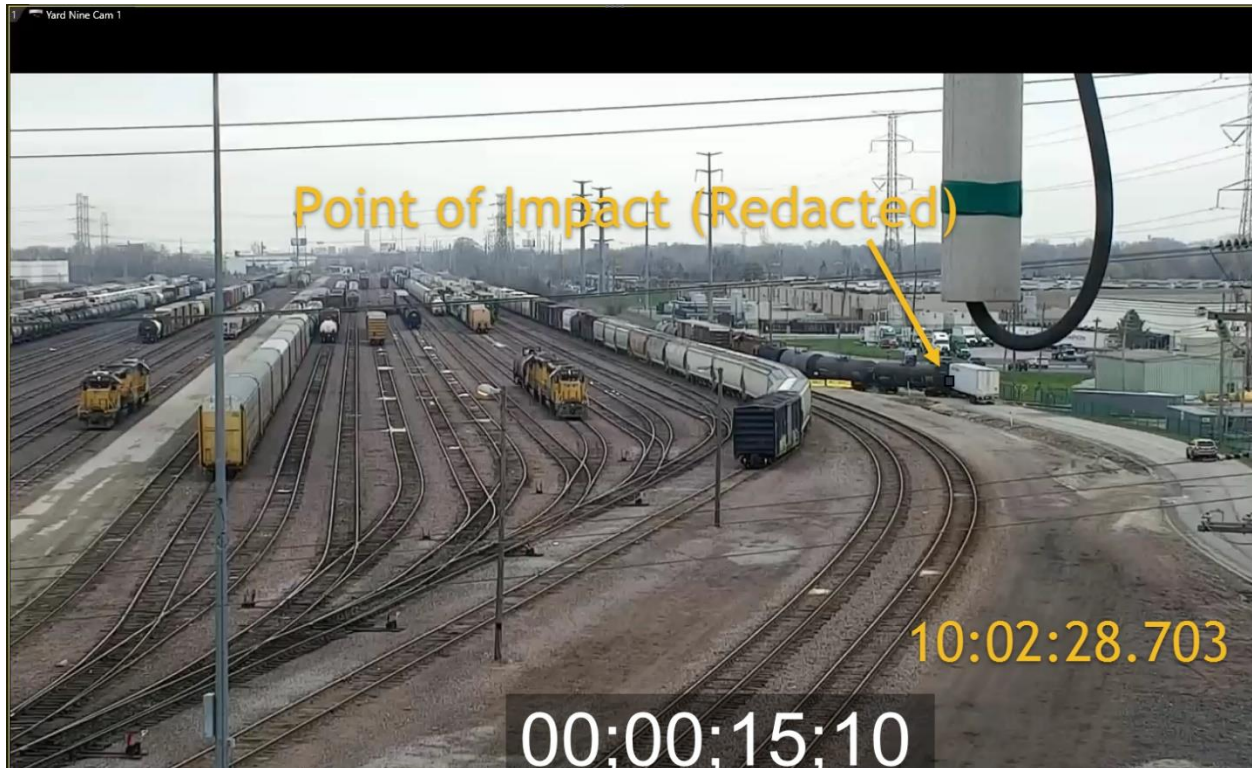
Continuing images showed that Impact occurred at 10:02:28.703. Figure 3 is a redacted screen capture of the frame at this moment.

Figure 3. A redacted security camera frame at 10:02:28.703.
